SECTION 1 – INTRODUCTION

PRINCETON PLACE 5 ON WIGGINS BAY

BONDURANT
ARCHITECTURE

Report Date:
February 15, 2024

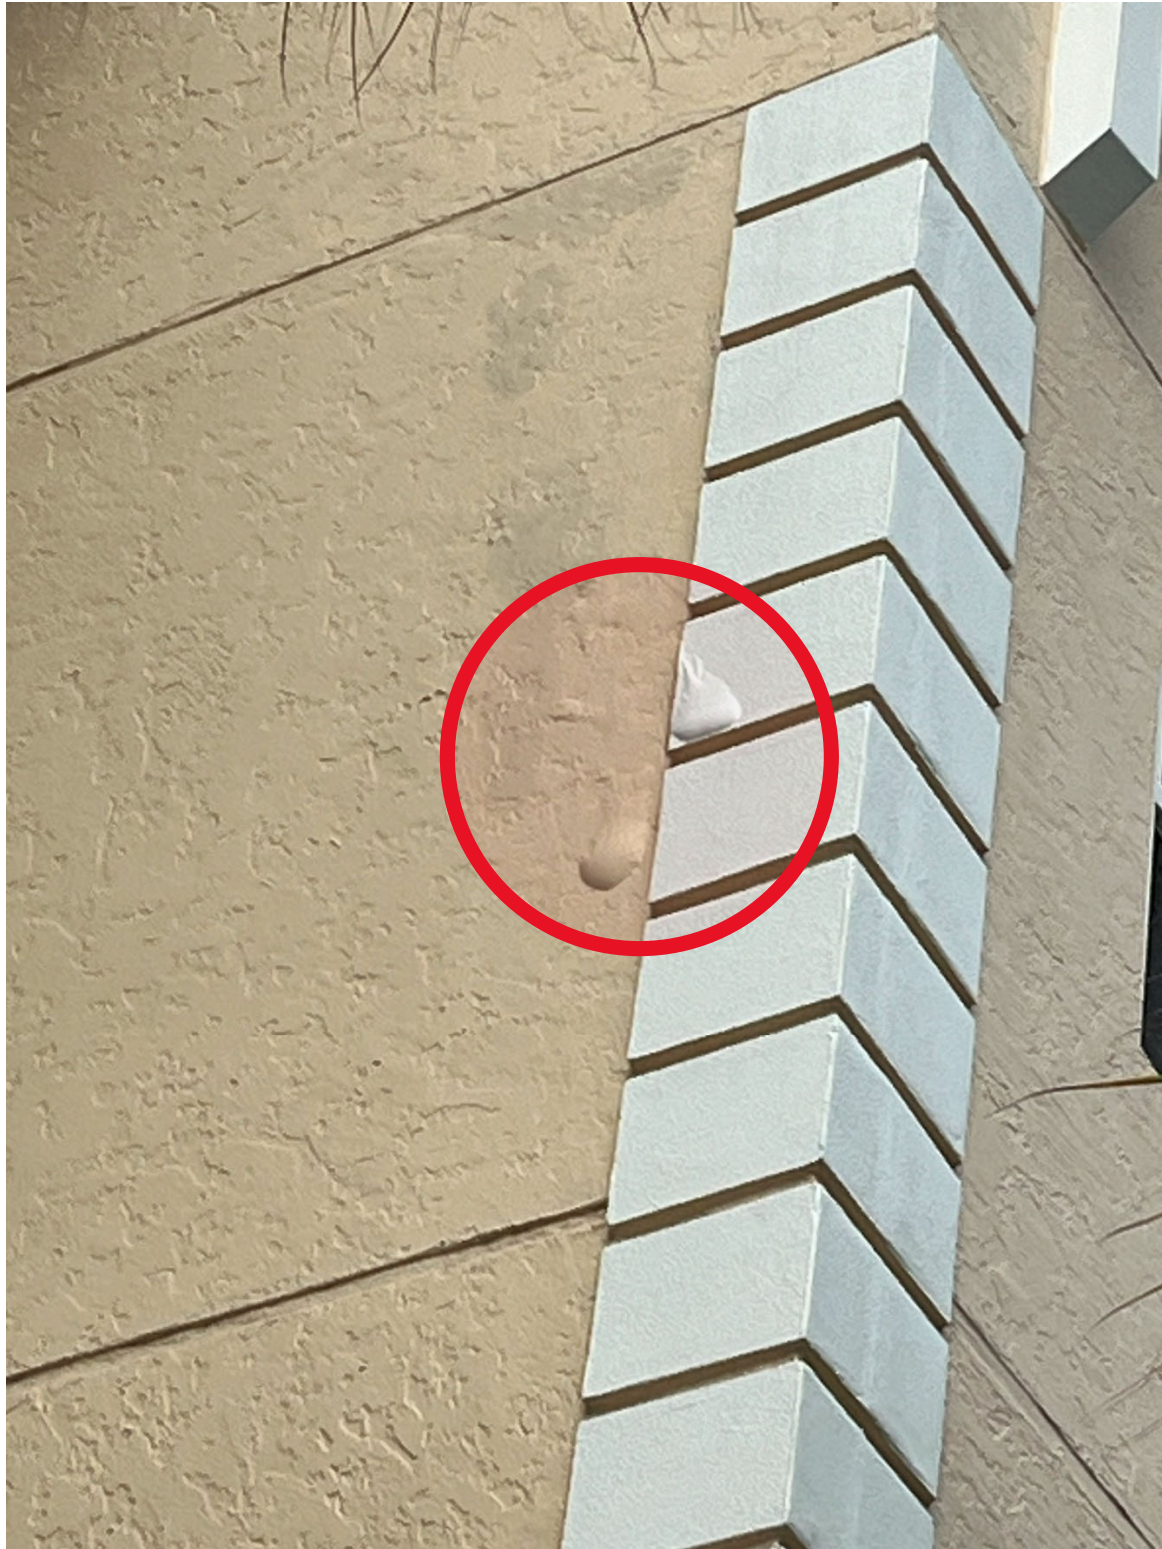
Bubble in Stucco Finish

On a rear outside corner, there were strange bubbles in the stucco. These appear to have some water behind them. Suggest having a qualified stucco technician repair these anomalies and be sure that no future water penetration will occur in this area. Mike Smith (HOA PRES.) thought this may be covered by the installer's warranty. Research that prior to authorizing repair.

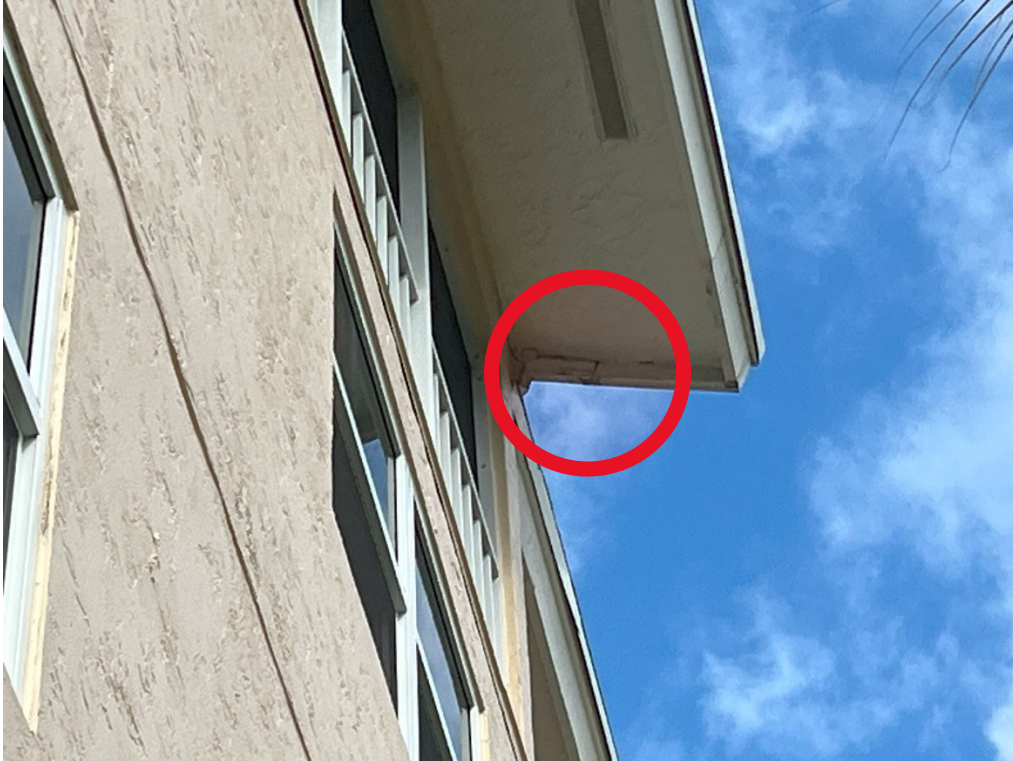
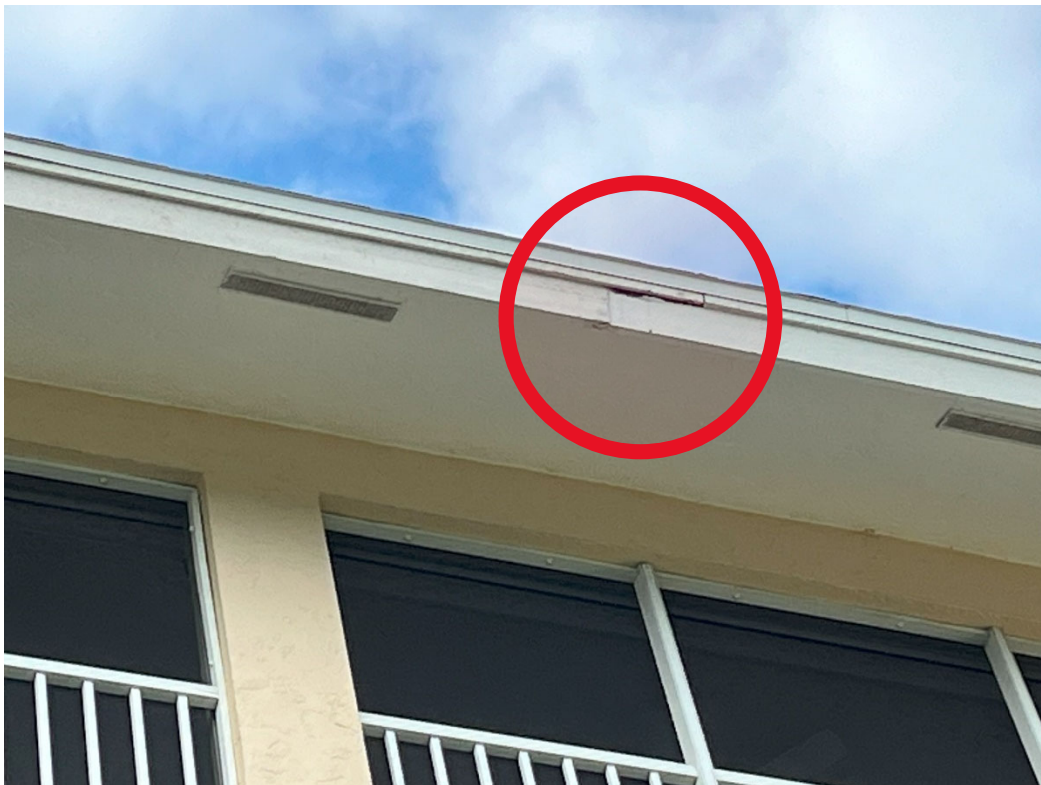
Dark Areas on Fascia Boards

Two fascia boards had dark areas on them that sometime indicate the presence of water deterioration and damage. Suggest having these inspected by a wualified technician and replaced as needed.

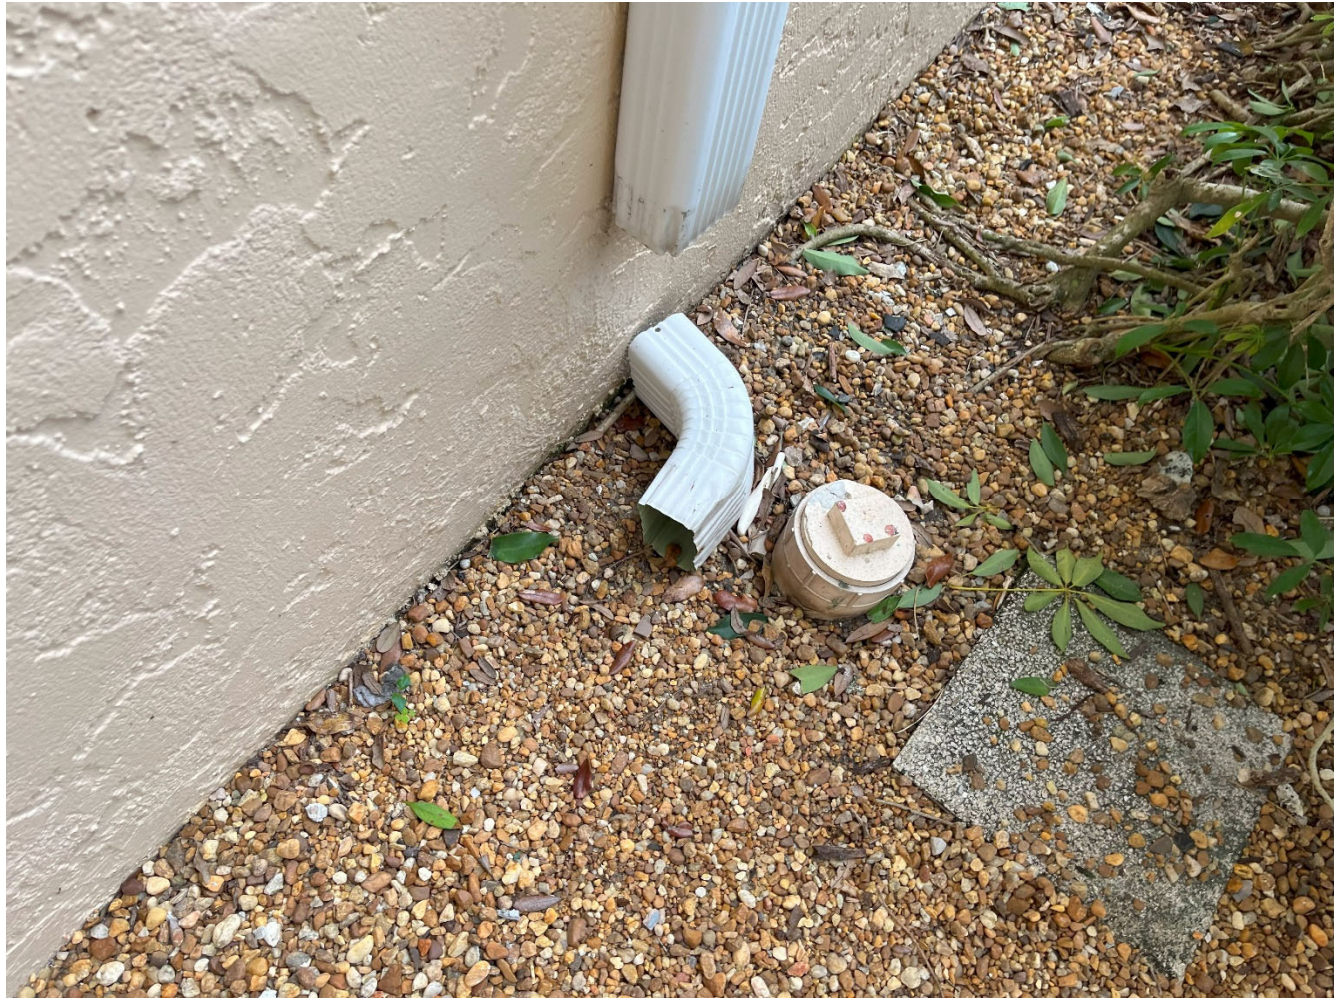
Disconnected Downspout Elbow

A downspout near the right end of the building was disconnected. This allows water to drain down the face of the building and into the building foundation, which can deteriorate foundation materials over time. Suggest having this elbow reattached then add an extension of at least 3'-0" to direct outflow well away from building surfaces. Consider adding extensions to any elbows around the building that do not have them.

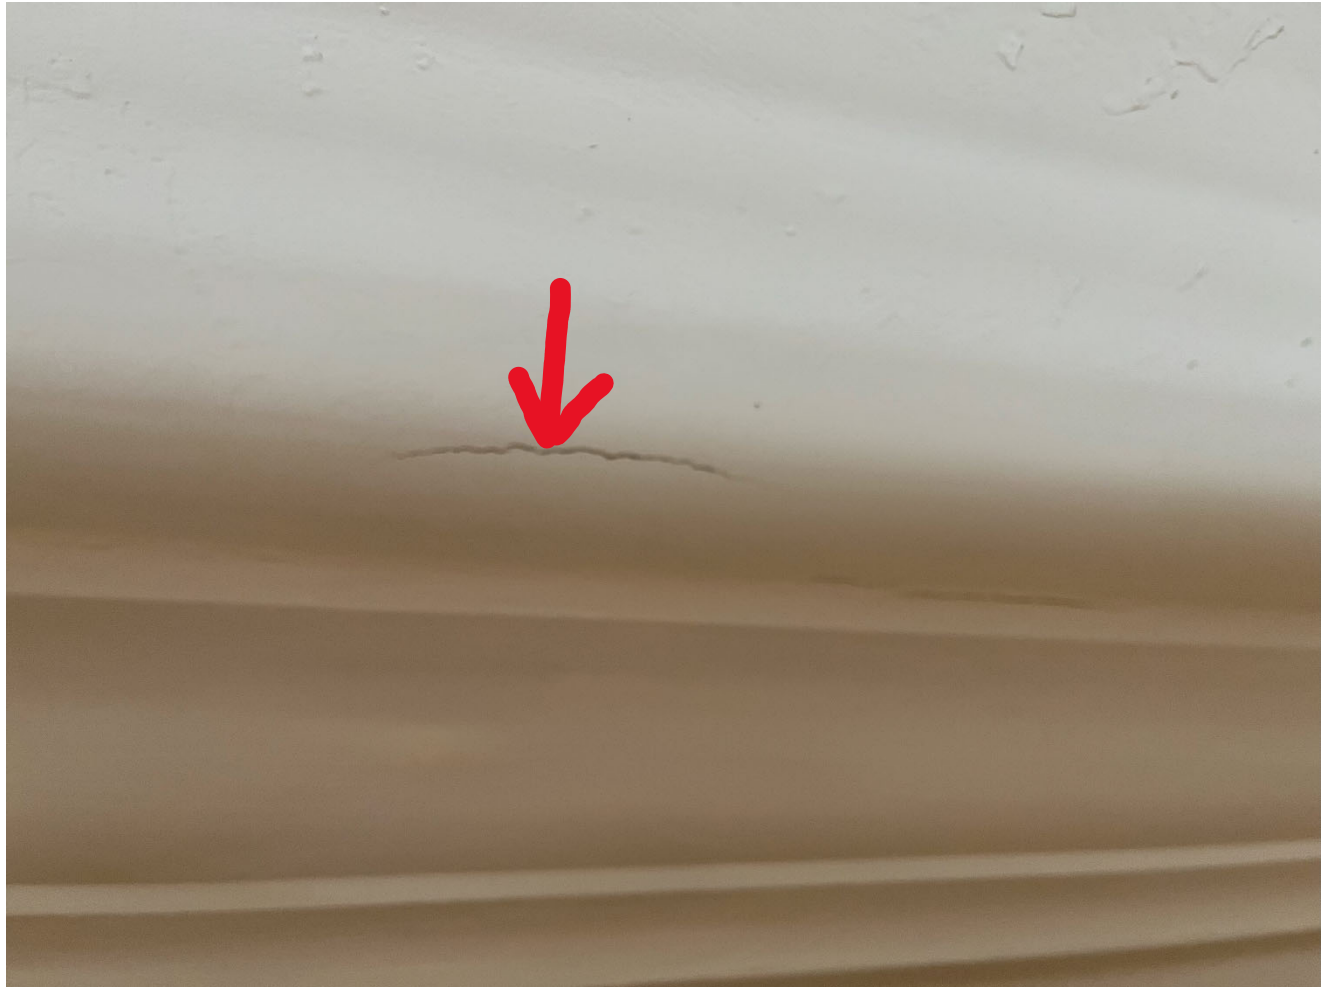
Unit 104 had a small crack over the Master Bedroom window that appeared to be cosmetic. Suggest having this crack repaired then monitor this area for any reappearance of cracks.

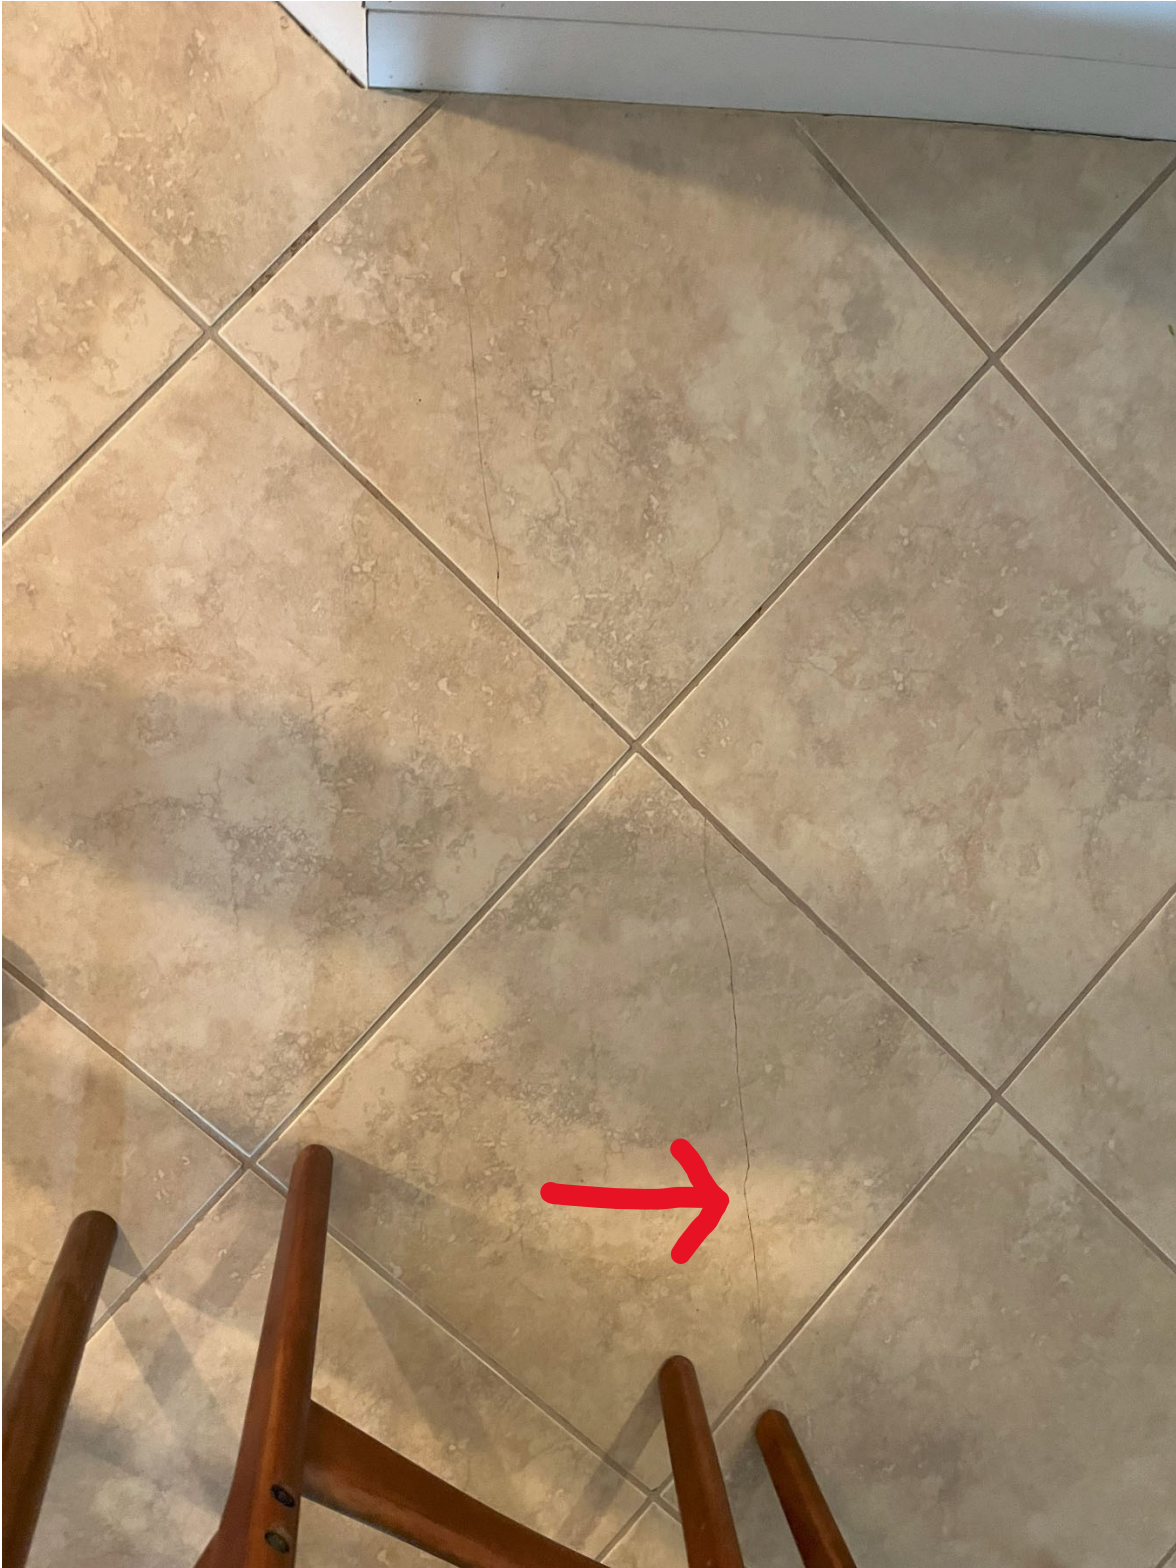
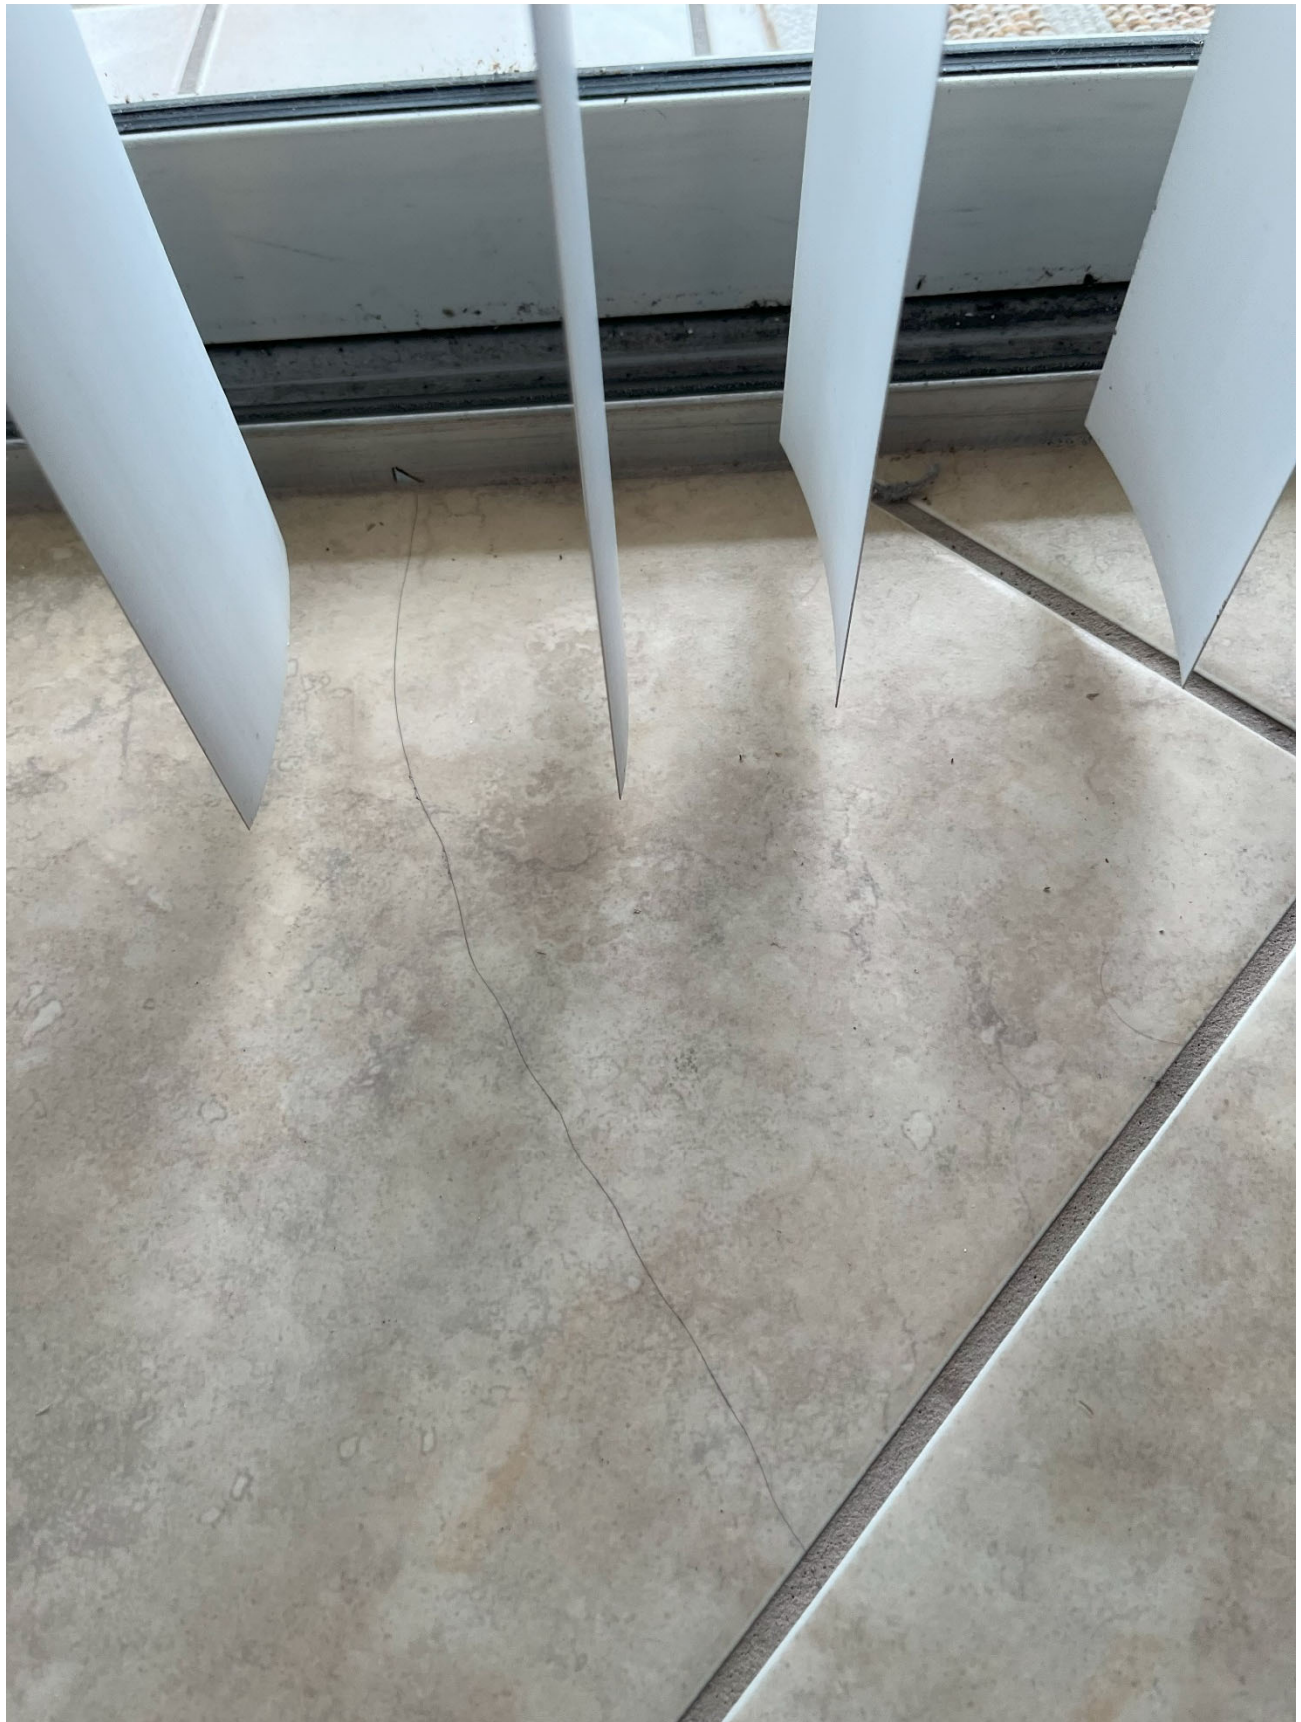
Unit 104

This unit had a series of cracks in the Living Room tile that were roughly in line with each other that ran almost the full length of the Living Room. Suggest having these broken tiles replaced and the supporting slab below this crack examined at that time for any apparent cracking or differential settlement.

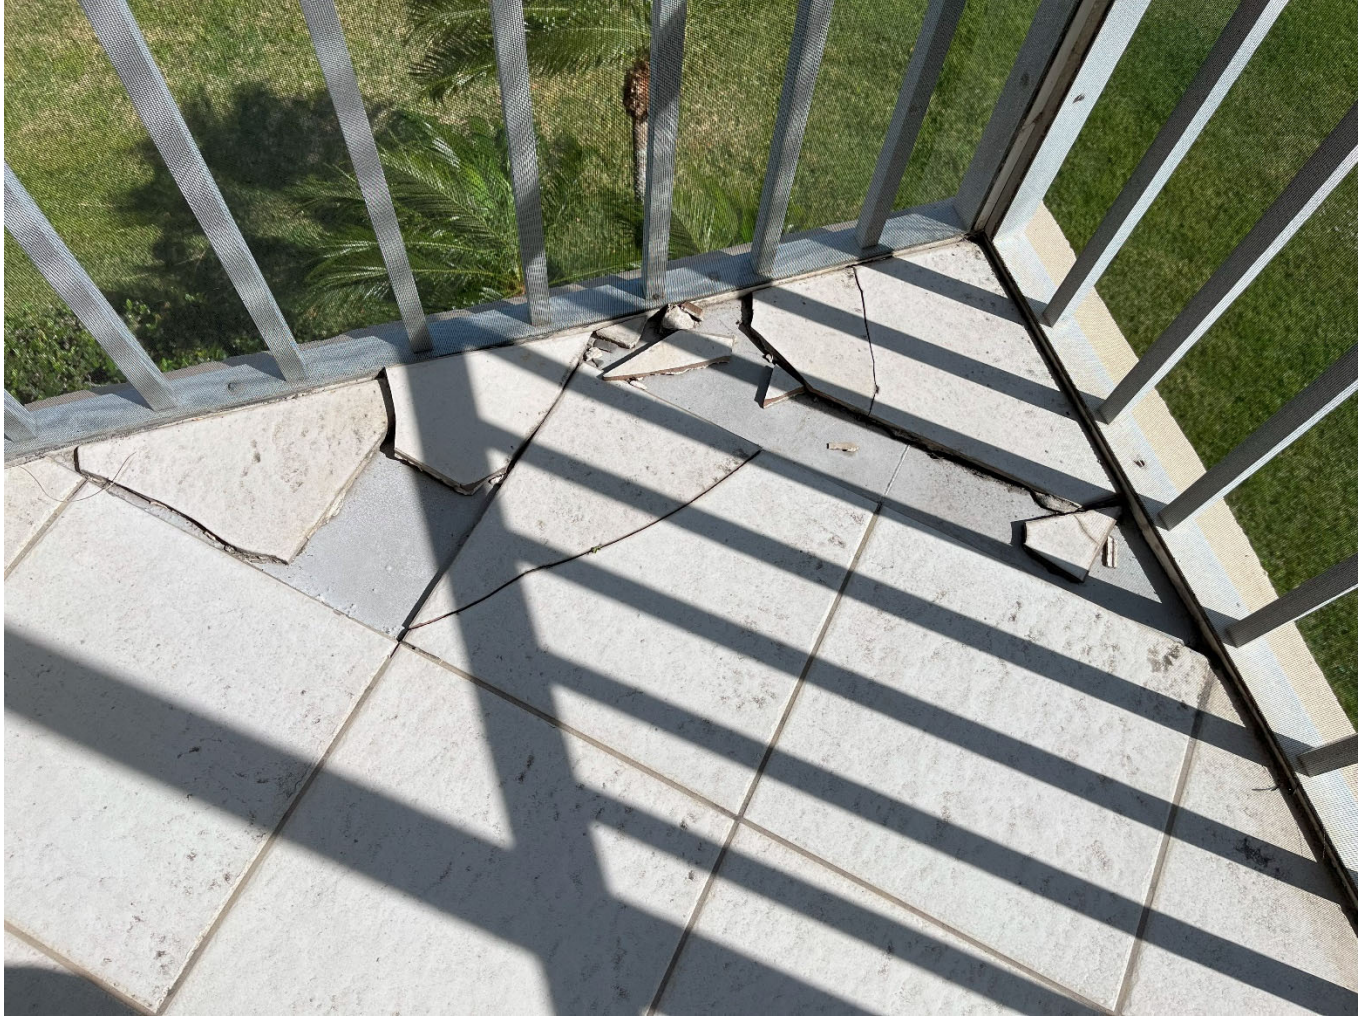
Unit 301 had some severe cracking of the tile on the floor of the lanai. This cracking was extensive involving several tiles but the underlying concrete slab did not appear to be damaged. Suggest replacing the damaged tiles and examining the underlying slab in the process to be sure it has not suffered any water damage after being unprotected. Make any repairs needed to maintain the integrity of the finished floor and the supporting slab below it.

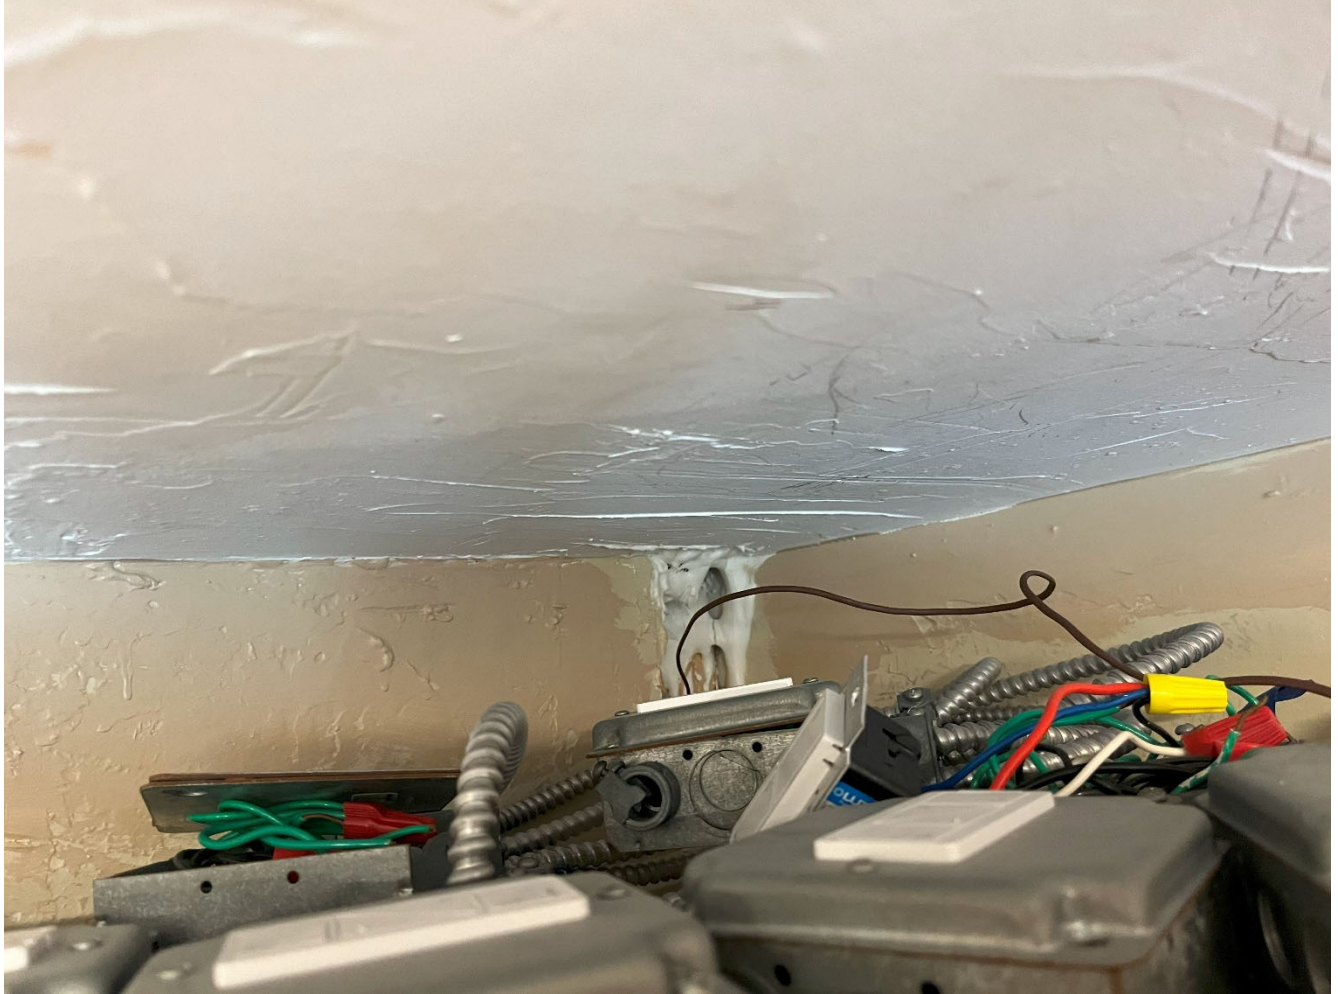
Unit 403 had a hole in the wall in the corner above the kitchen cabinets. Be sure this hole gets sealed up to prevent use by vermin. Also review wiring condition and provide junction boxes as needed to protect connections secured by wire nuts.

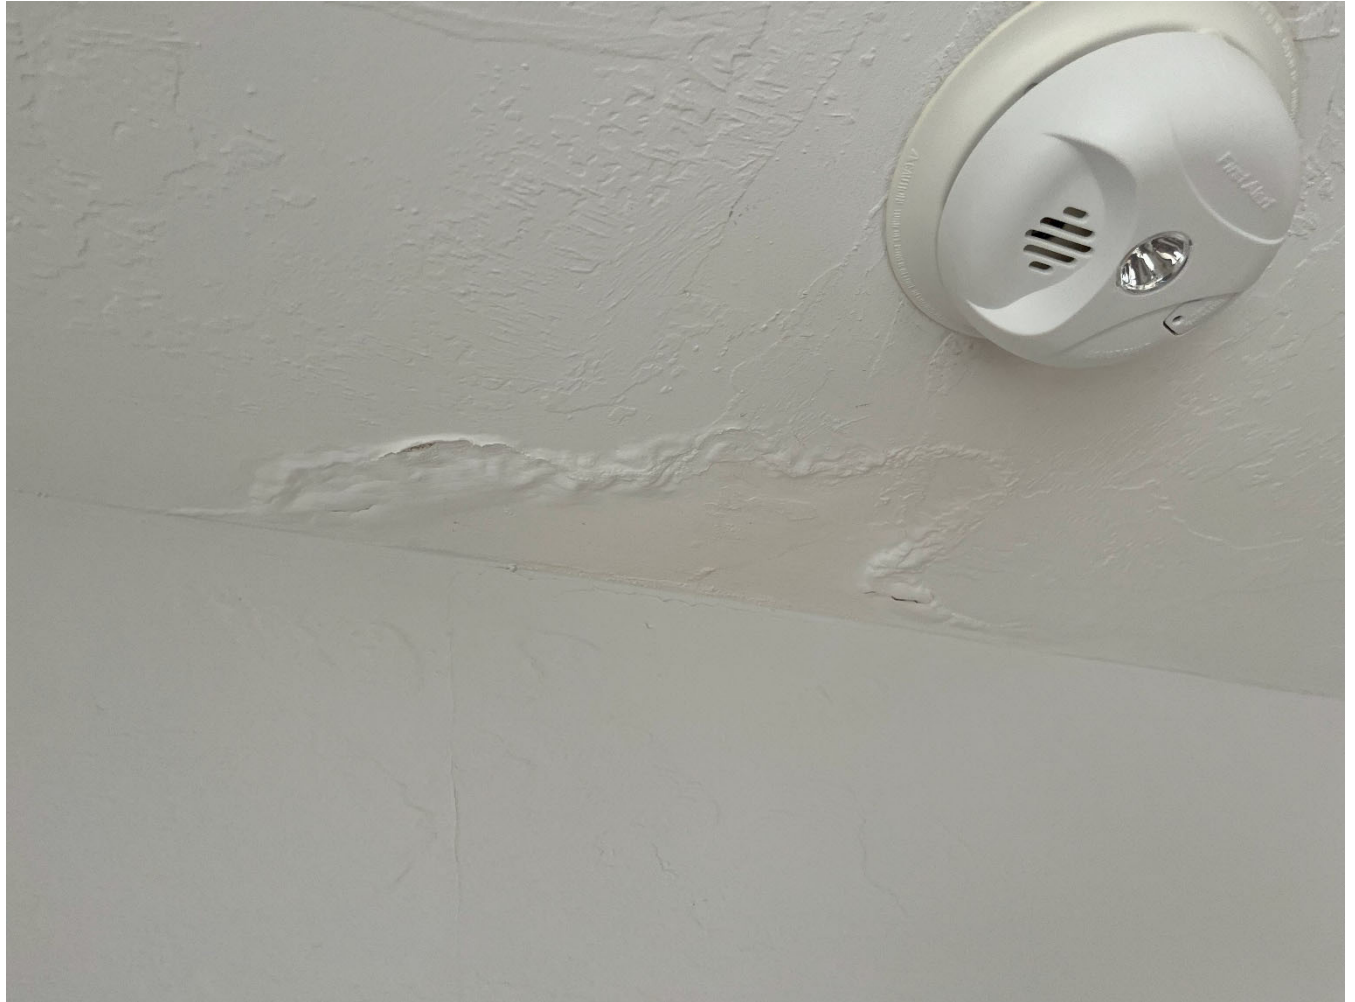
Unit 404 had some evidence of water damage over the Master Bedroom door near the smoke detector. Suggest repair of this condition then monitor the area to see if any further evidence of water penetration shows up. Most likely the result of a water leak in the unit above that has been resolved as the stain did not look damp or active in any way.

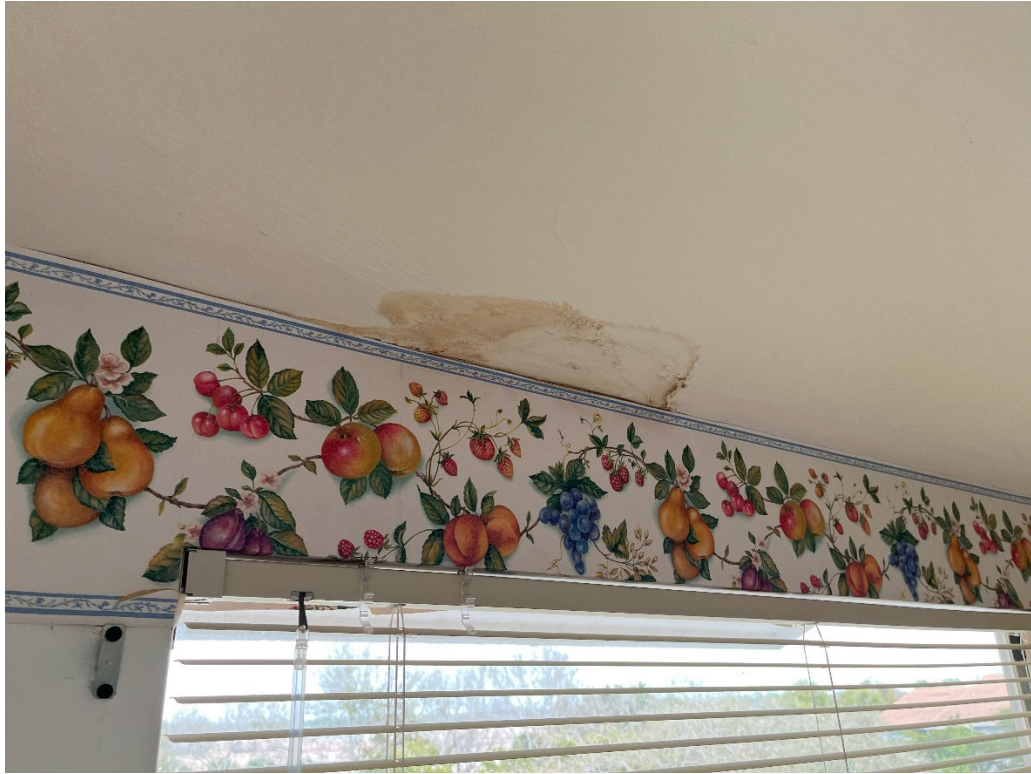
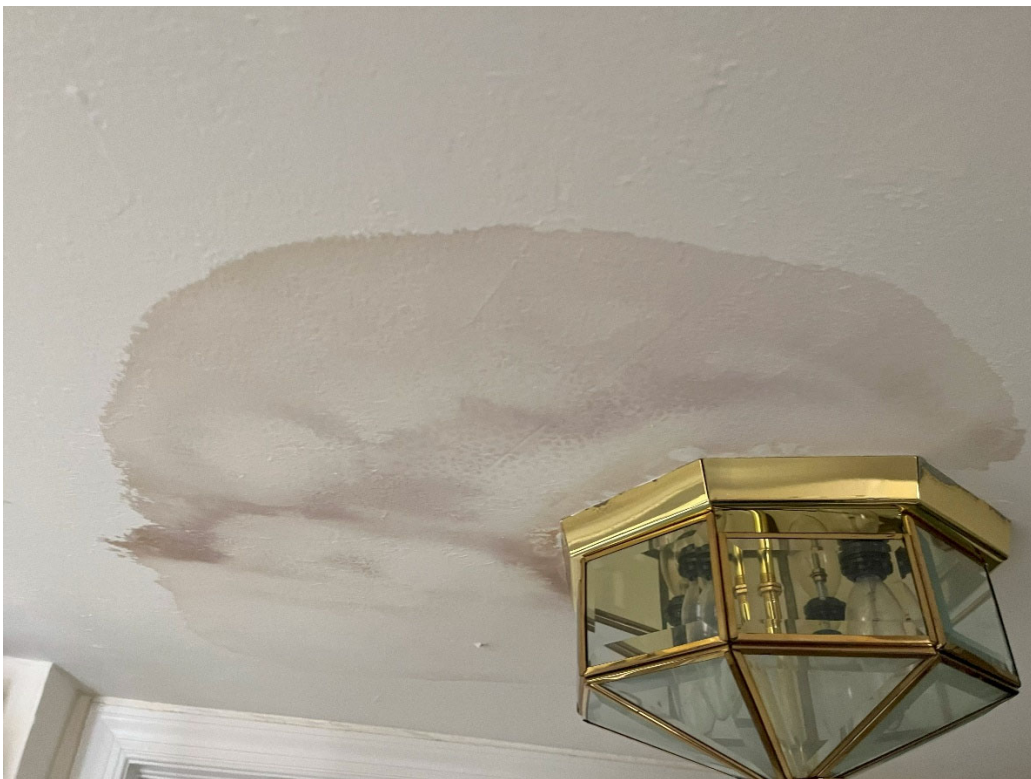
Unit 407 had water stains over the Kitchen dining area and around the light fixture in the hall leading to the Guest Bathroom. Be sure water issues have been resolved, then repair the damage to the ceilings. Suggest monitoring these areas to see if water issues persist.

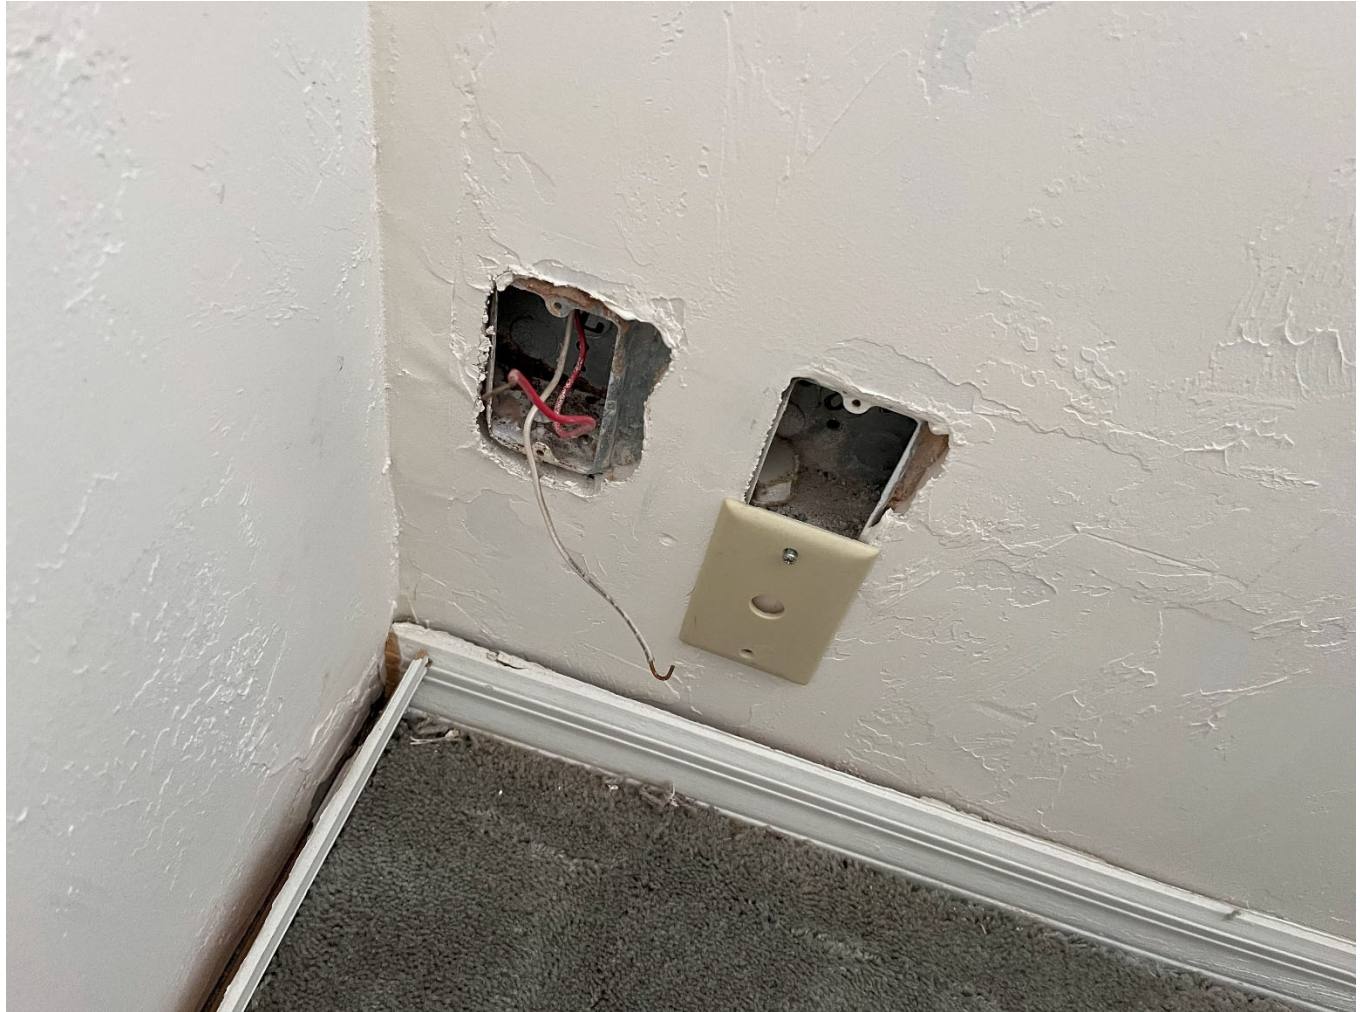
Unit 407 (Cont.)

Also in Unit 407, there were exposed wires in junction boxes without a cover. Suggest having a qualified electrician correct this condition. There also seemed to have been an electrical outlet eliminated in this same wall. Have electrician determine if this outlet was disconnected according to code and if the resident was aware that the outlet had been eliminated.

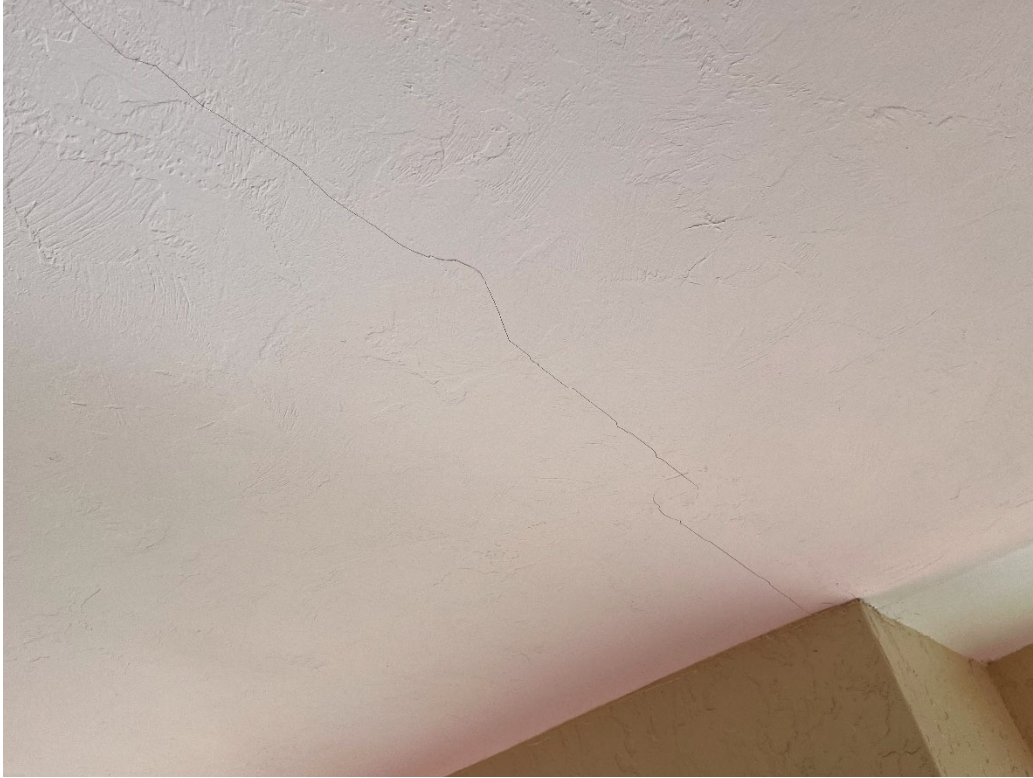
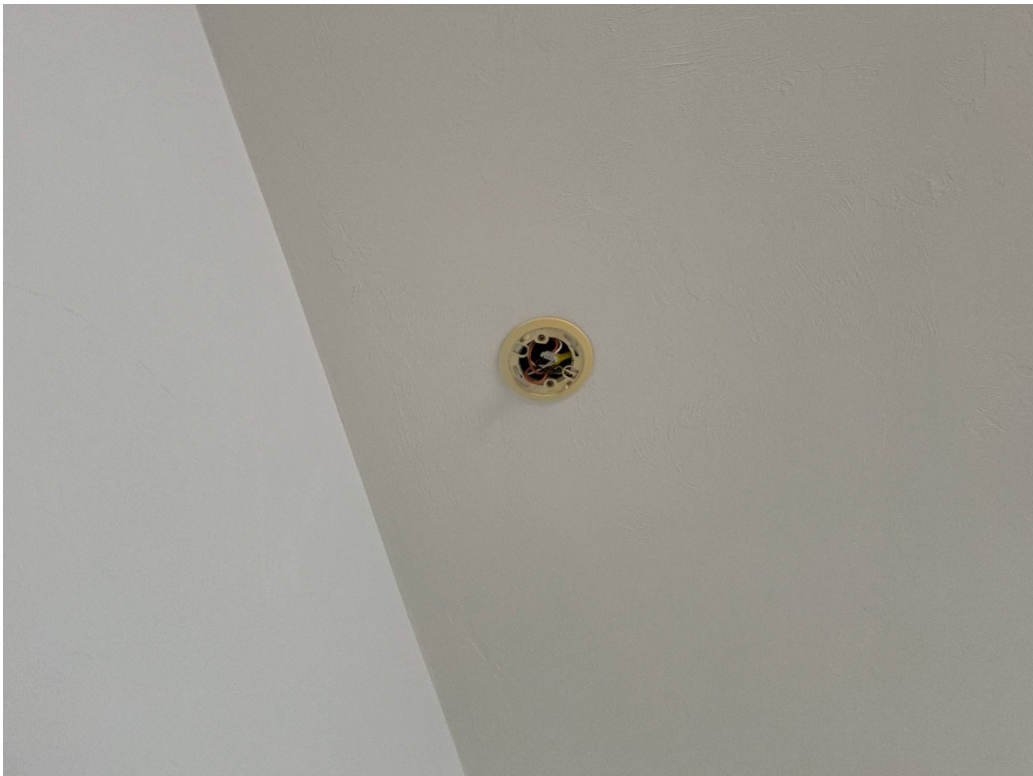
Unit 504 had an odd-shaped crack in the middle of the lanai ceiling. Crack appeared to be cosmetic but should be repaired to see if it attempts to reassert itself. Also this unit had a missing smoke detector which is considered a safety issue. Have this smoke detector replaced as soon as possible.

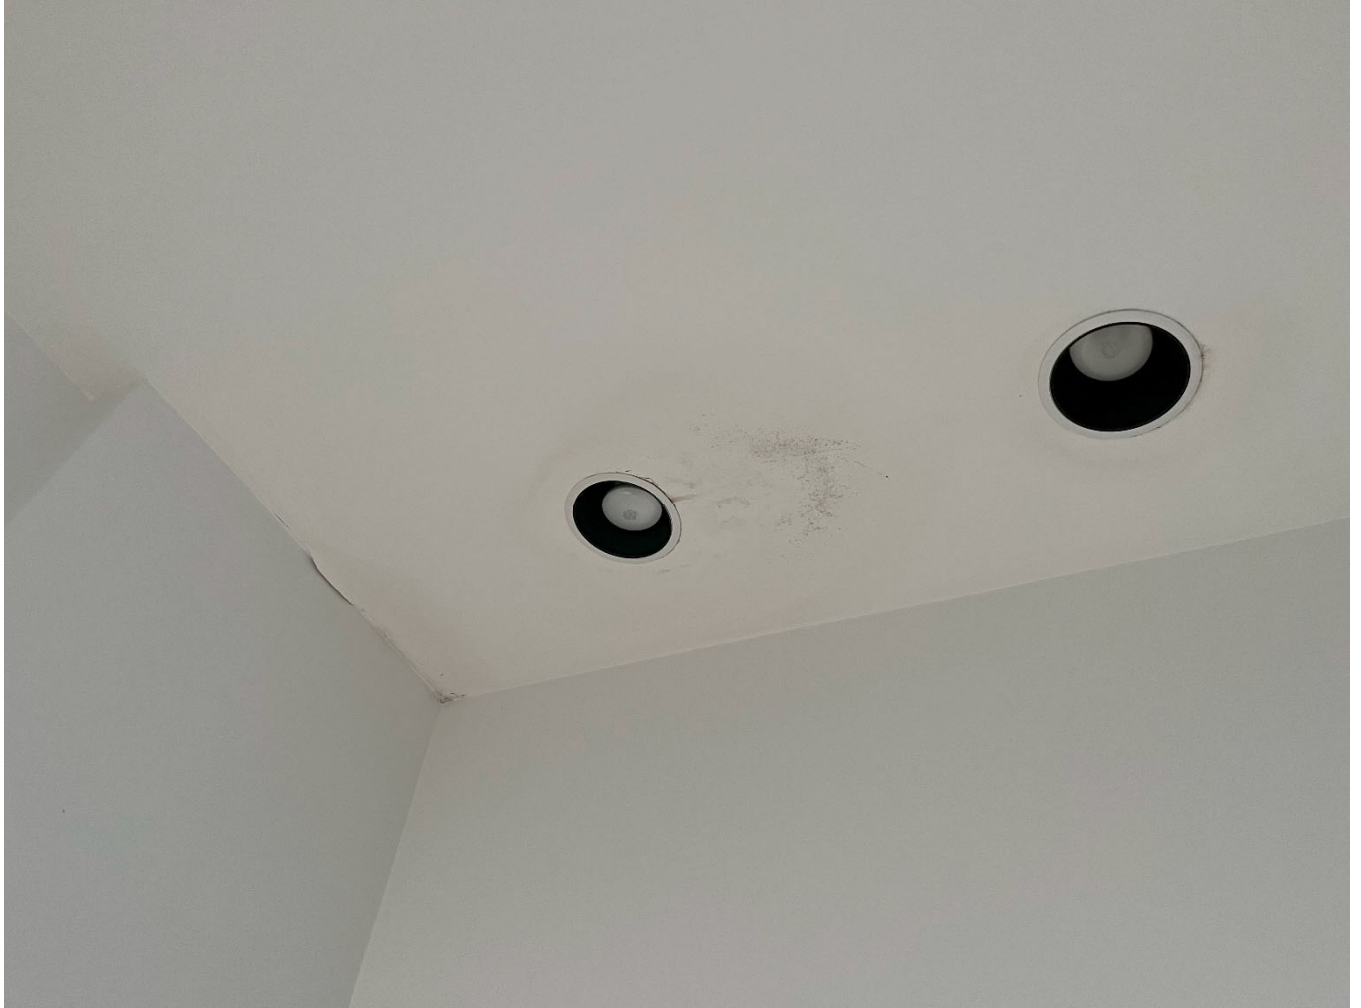
Unit 504 (Cont.)

Unit 504 also had some evidence of a water leak above the Master Bathroom sinks. These are thought to have been resolved when the new roof was repaired after Hurricane Ian in 2022. Suggest having these water stains painted over using a high hide primer (i.e. Kilz), then monitor the area for any reappearance of water staining.

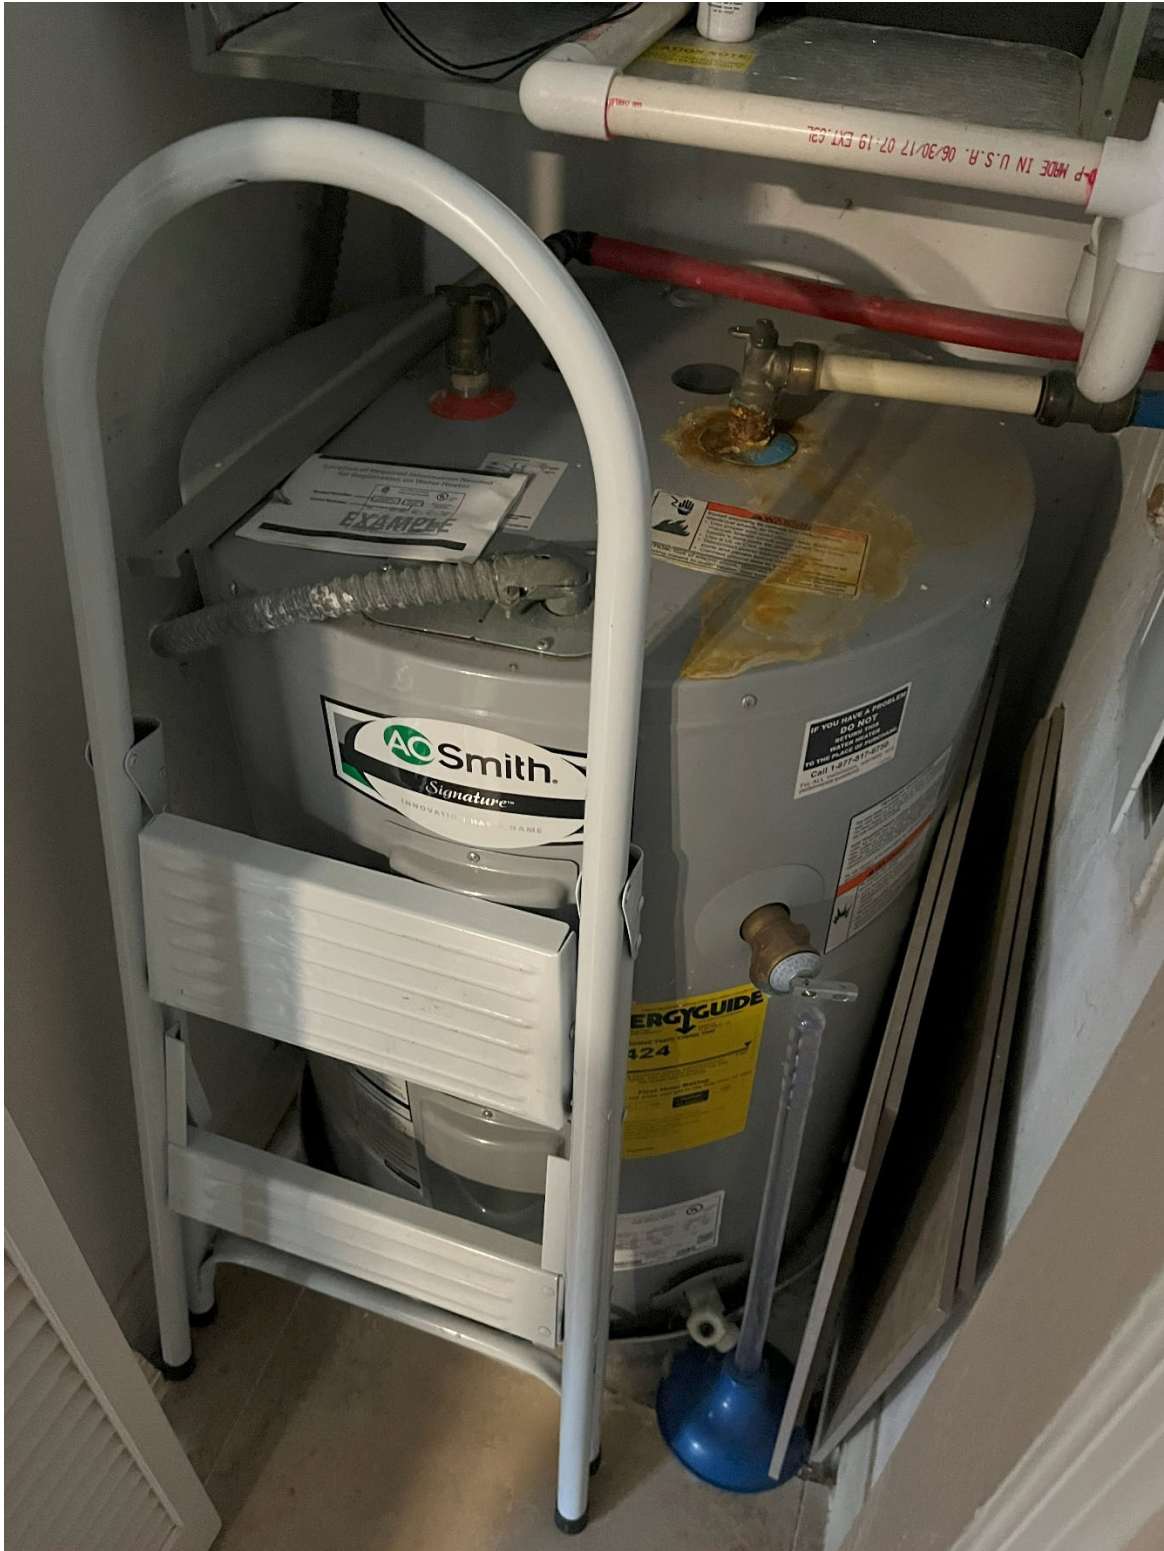
General Note About Water Heaters

In multi-unit buildings like this one, it is preferred to have water heaters replaced every 12-15 years to avoid tank failures and the severe water leaks created by them. Suggest all residents check the age of their water heater and replace soon any that are 15 years old or older. Watch for signs of rusting or dampness which signal the urgency of replacing the water heater sooner rather than later.
