SECTION 1 – INTRODUCTION

PRINCETON PLACE 5 ON WIGGINS BAY

BONDURANT
ARCHITECTURE

Report Date:
February 15, 2024

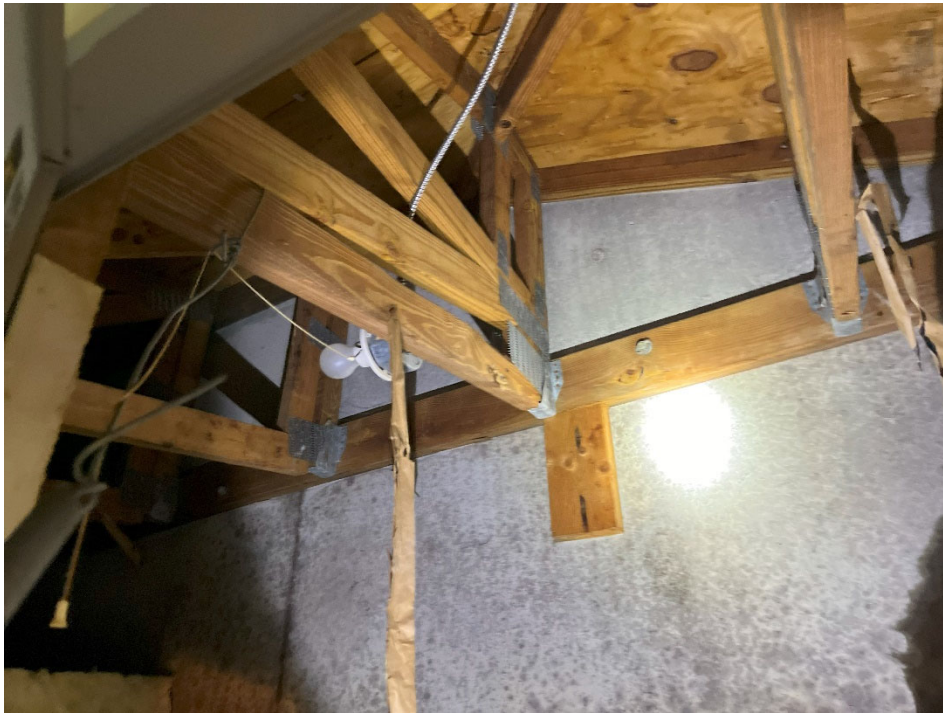
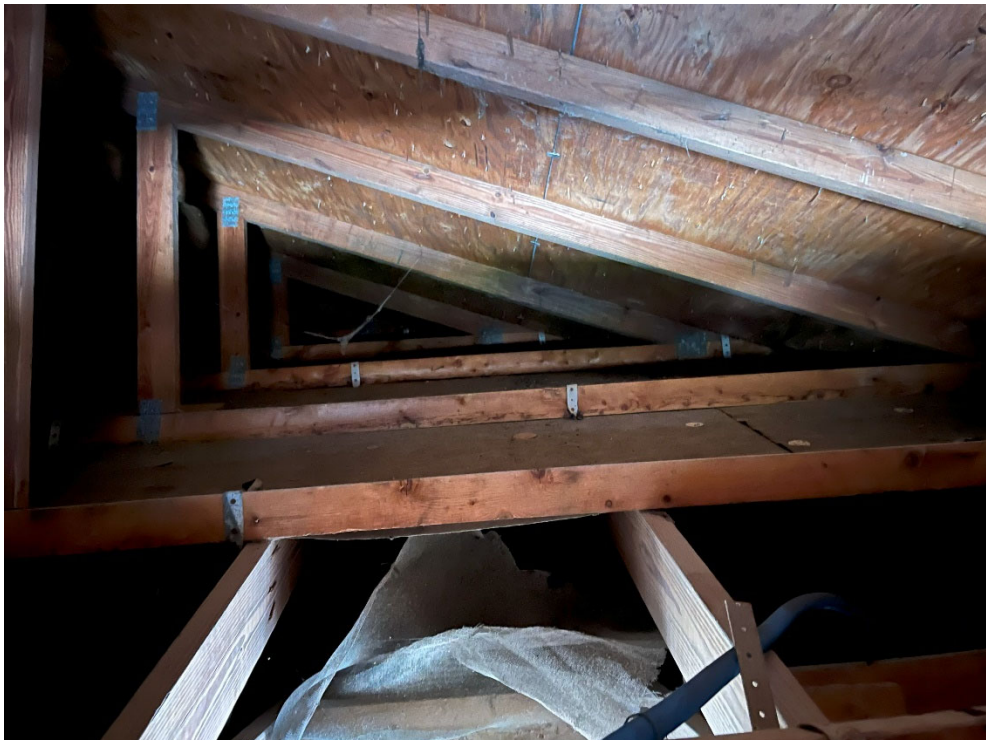
Typical Roof Framing Components

The attic was entered to assess the roof framing. Framing consisted of pre-engineered wood trusses. All appeared to be in good condition with no anomalies apparent. Required hurricane clips and tie downs were observed in place and functional. All observed gussets were tight and of adequate size for the truss.

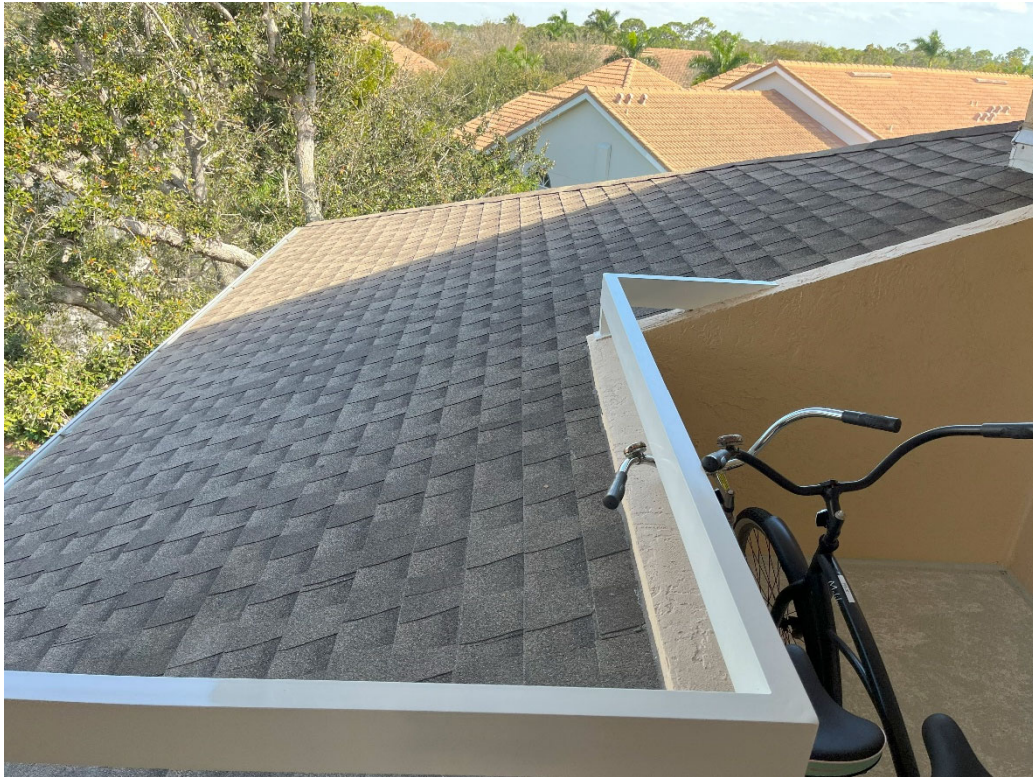
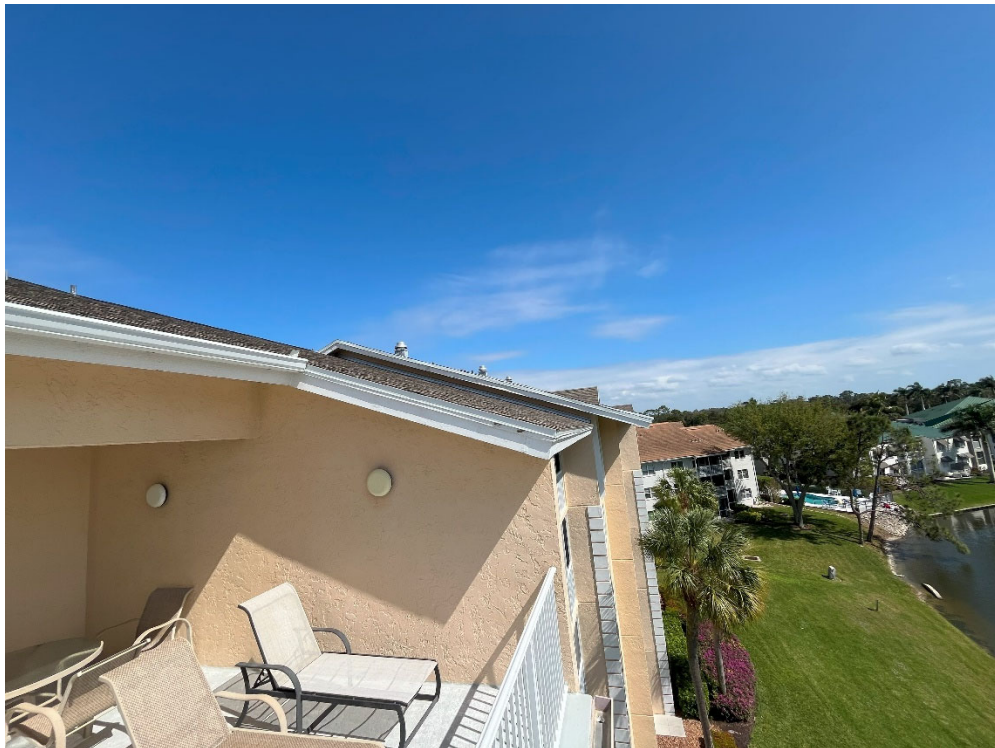
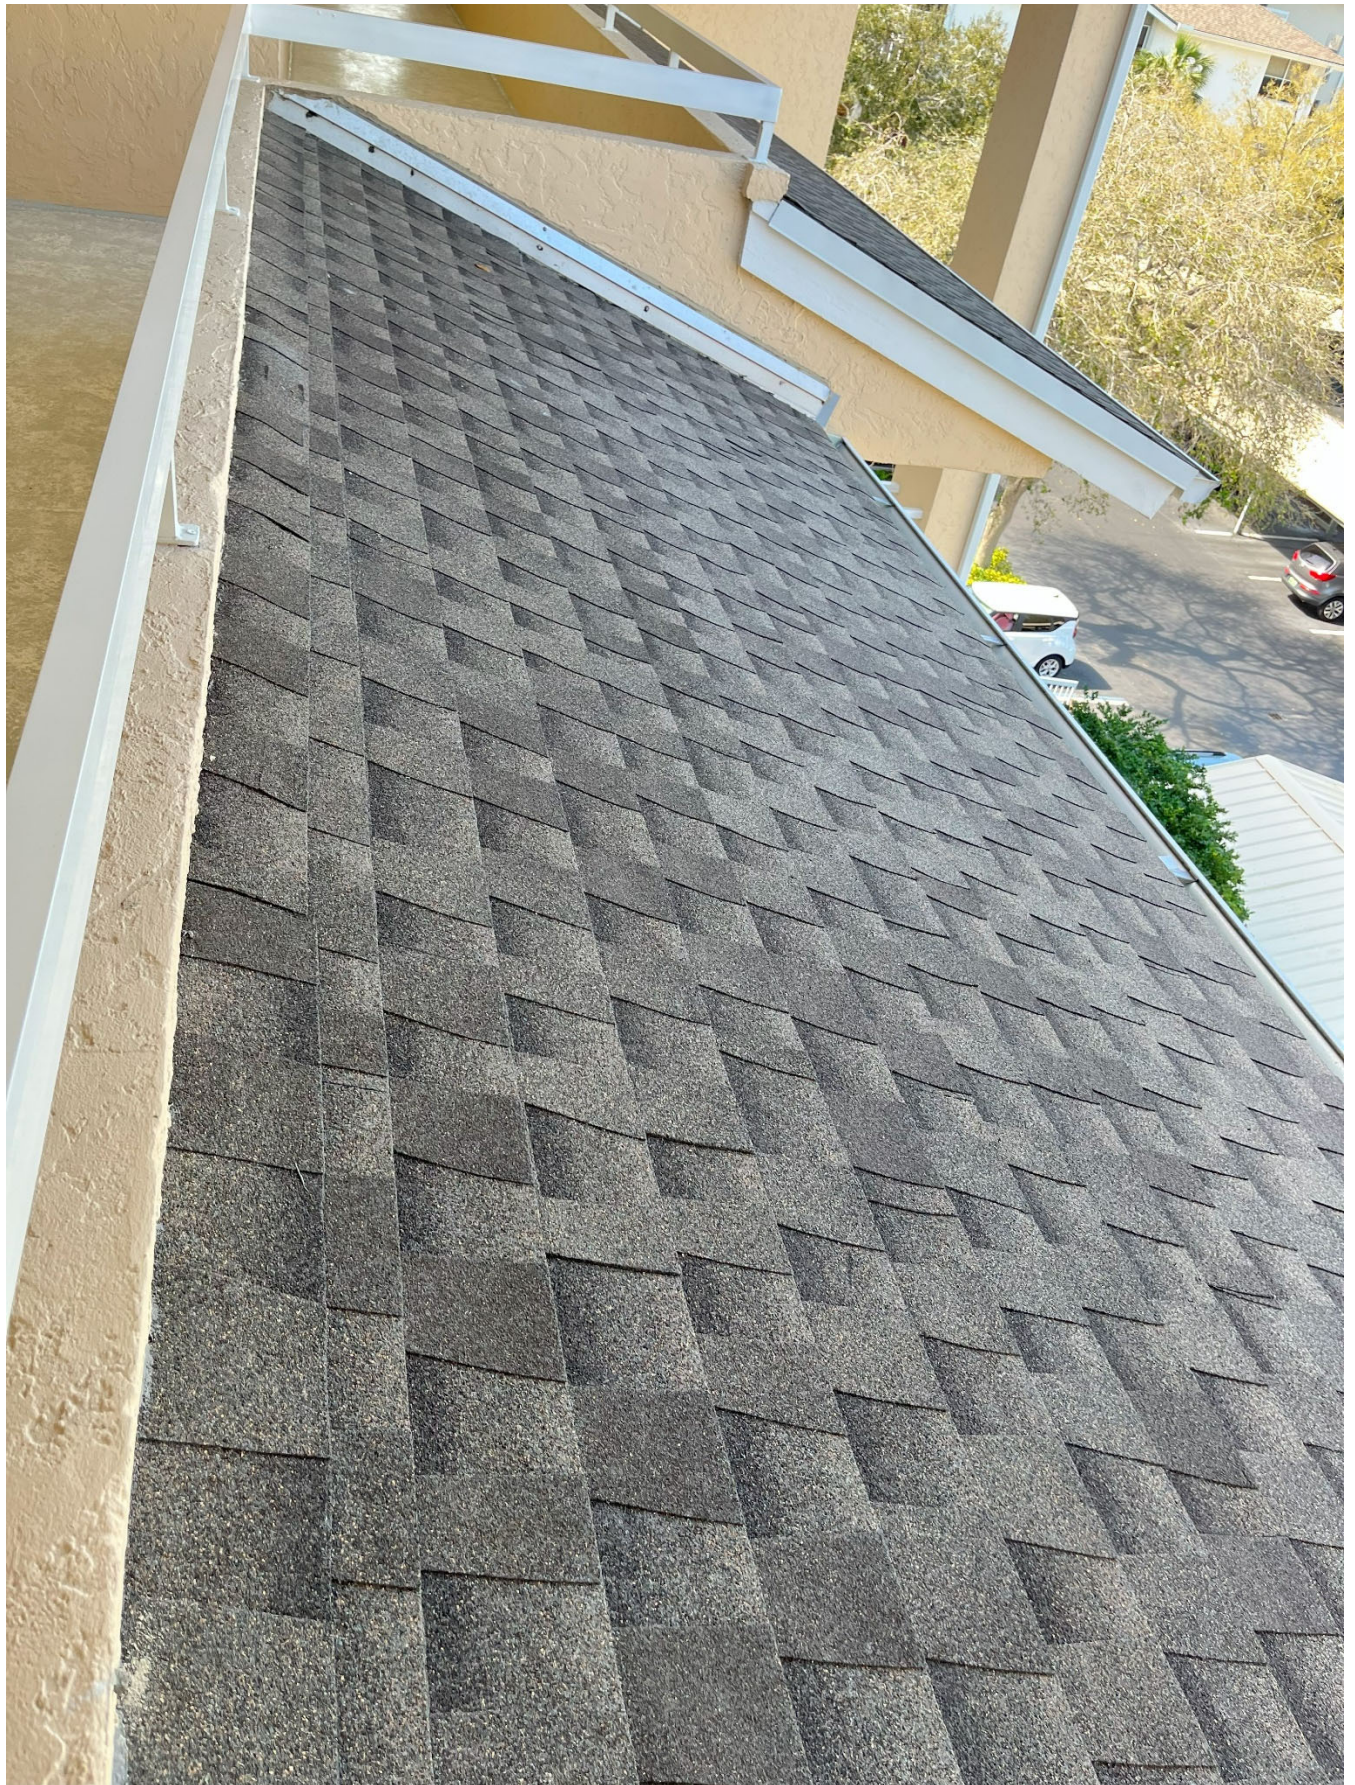
The dimensional fiberglass composition roof on this building was in good condition. Mike Smith (Board President) said the roof had been replaced in 2017 after Hurricane Irma. Roof was repaired in 2022 after Hurricane Ian. Roof will most likely have a remaining life expectancy exceeding 20 years. Representative photos:
