SECTION 1 – INTRODUCTION

PRINCETON PLACE 5 ON WIGGINS BAY

BONDURANT
ARCHITECTURE

Report Date:
February 15, 2024

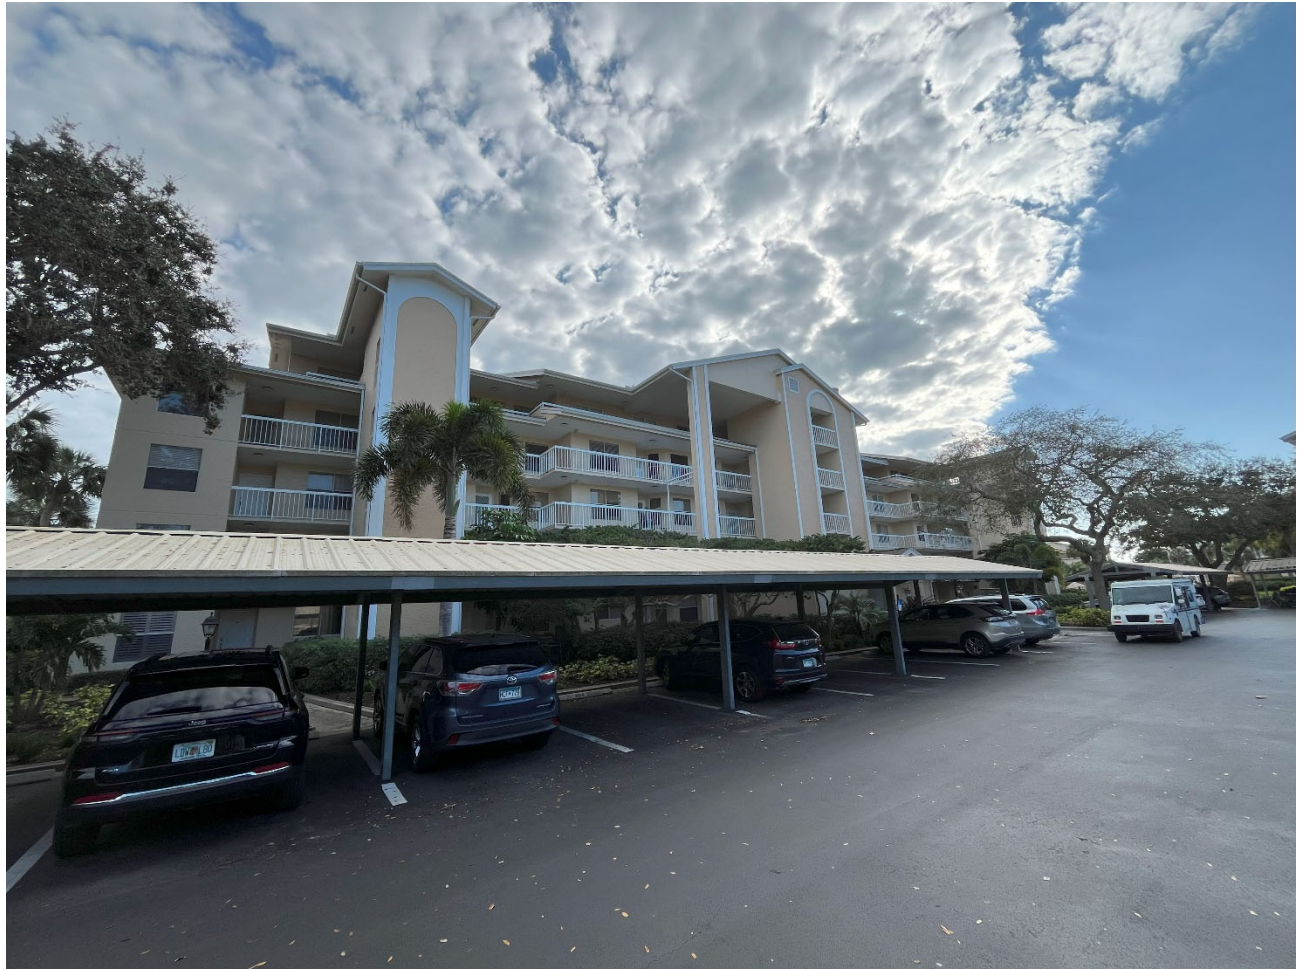
Front View

Princeton Place 5 has an exterior of cementitious stucco. Exterior is generally in good condition with no hairline cracks observed in the stucco. See comments and photos following:
